**Hebron, NH**

# Tree Inventory

## Hebron Town Common

June 6, 2016

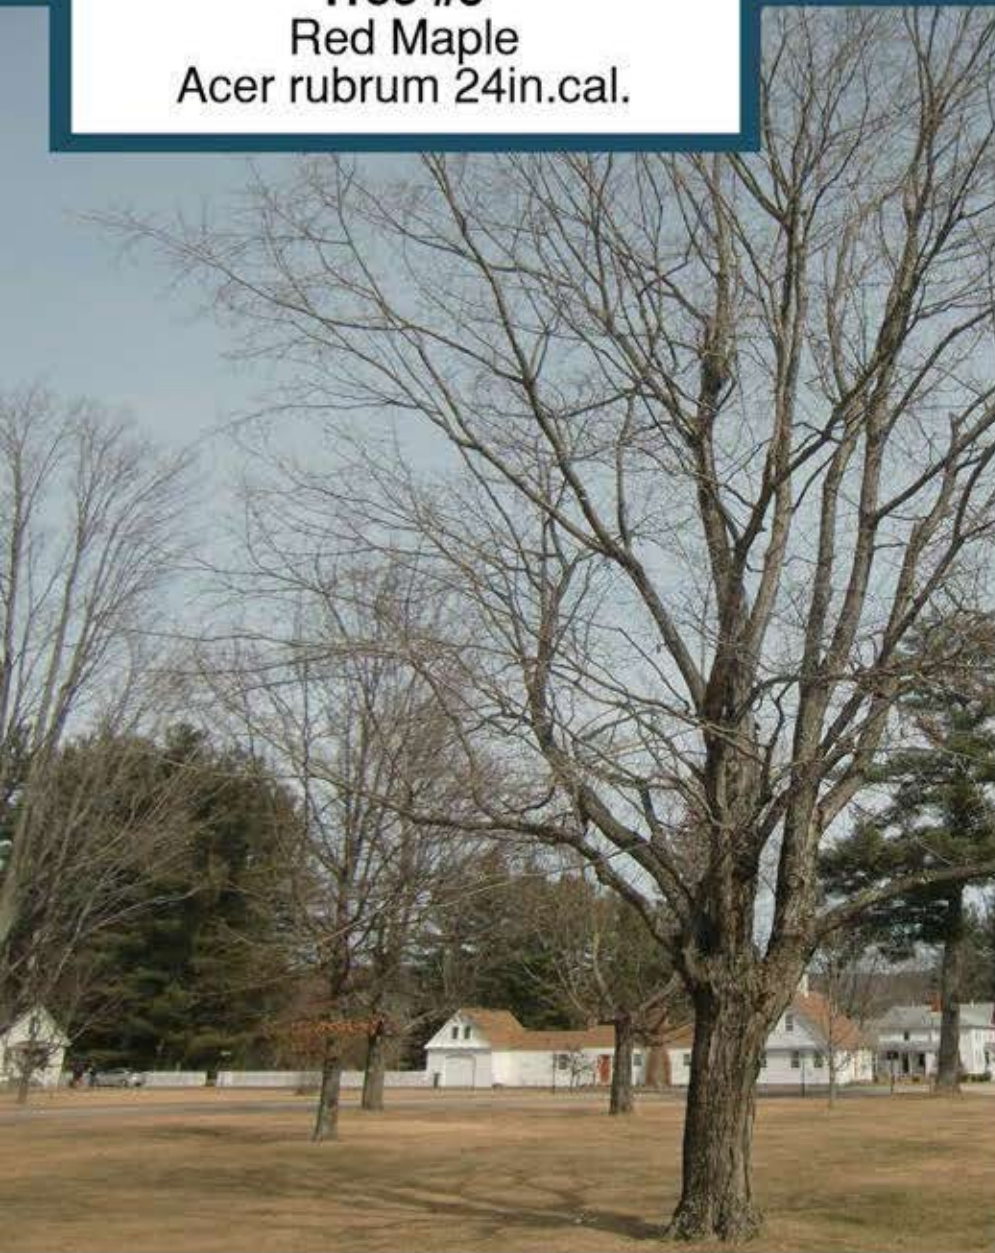
**Tree #5**  
**Red Maple**  
**Acer rubrum 24in.cal.**

**1. Condition** - Good condition there is some decay just starting under the 18 in side branch

**2. Save or Remove** - Save

A licensed arborist should be hired to prune out the dead wood in the tree.

Aerate and fertilized the root zone of the tree.

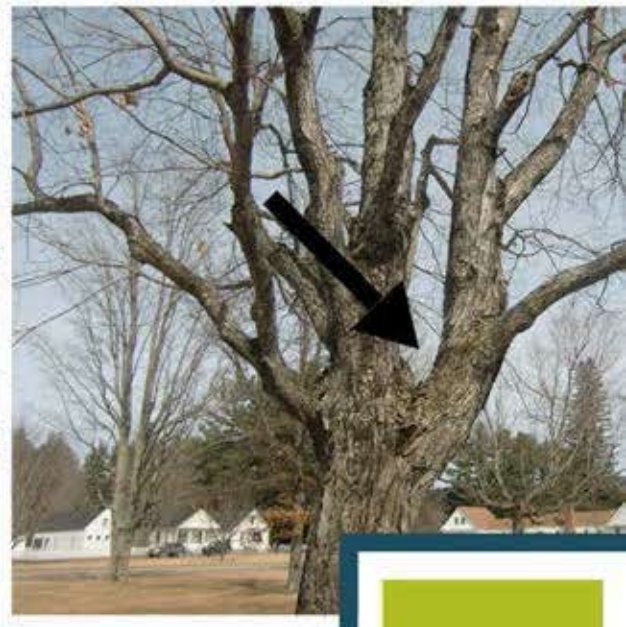
The large 18in side stem of the tree should be cabled to the main stem of the tree to keep it from breaking off as a result of heavy snows. (bottom right picture) (Fungus top right picture).

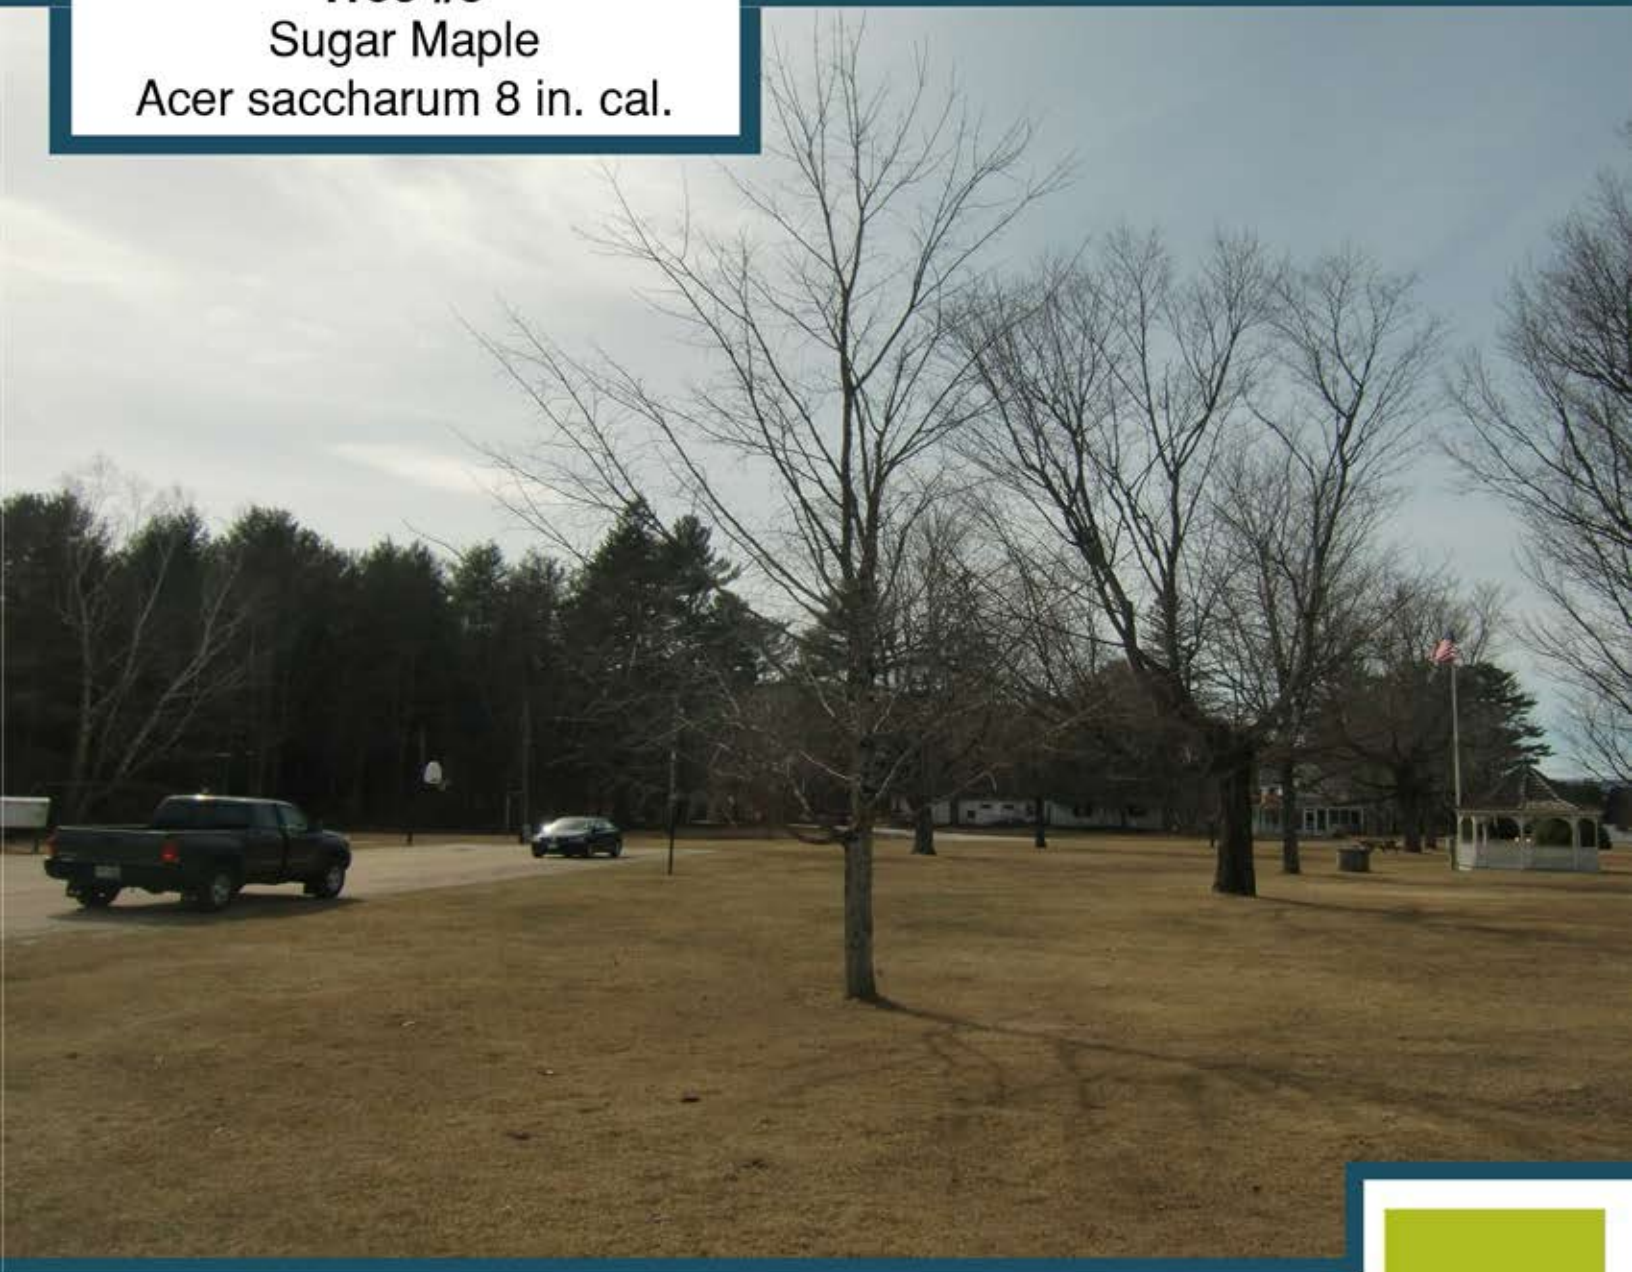
**Tree #8**  
Sugar Maple  
*Acer saccharum* 8 in. cal.

**1. Condition - Good**

**2. Save or Remove - Save**

- a.** There is some dead wood in this young tree. This is somewhat unusual for a tree this young. Some minor pruning of dead wood is needed. At some point remove the branches that are lower than six (6) feet above the ground. Root fertilize the tree and aerate the soil in the root zone of the tree
